Superior Coal Mines,
Concrete Foundation
Sections 28, 29, T21N, R102W
Horse Thief Canyon
Old Superior Mines and Townsite
about 1/4 mile north of South Superior
Sweetwater County < South Superior Vicinity
Wyoming

HAER No. WY-51-V

Superior Coal Mines, Concrete Foundation
HAER No. WY-51-V

Concrete Foundation: 48SW4068, Structure V (NE/NE/SW/NW Section 28, T21N, R102W 12/668720E/4625800N).

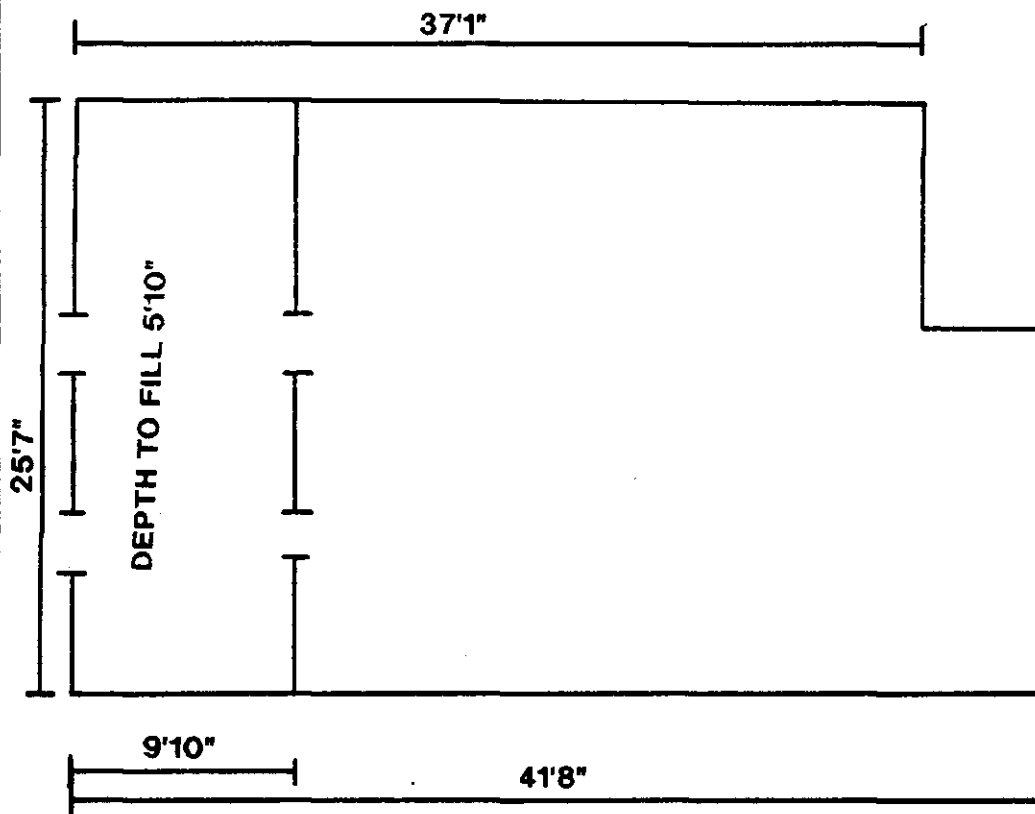
Concrete Foundation
Superior Coal Mines,
HAER No. WY-51-V
(Page 2)

The foundation is rectangular in shape with the long axis oriented from east to west. The overall dimensions are 41 feet 8 inches east to west by 25 feet 7 inches north to south. The foundation is divided into two rooms, a west room which is 25 feet 7 inches north to south by 9 feet 10 inches east to west. This room is 5 feet 10 inches deep to fill. The east room is larger, being 27 feet 3 inches east to west by 25 feet 7 inches north to south. This room is filled nearly to grade with earth. The east room has a short wing extending eastward from the east wall. This wing is badly collapsed making measurements uncertain. The foundation has four openings, two in the west wall and two in the wall dividing the west room from the east room. The southernmost opening in the west wall is 5 feet 5 inches north of the southwest corner. The opening is 1 foot 11 inches wide. The second opening is 7 feet 11 inches north of the southwest corner and is also 1 foot 11 inches wide. The two openings along the interior wall are also 1 foot 11 inches wide. The southernmost is 5 feet 5 inches from the south wall and the northernmost is 7 feet 4 inches from the south wall.

The foundations are in poor condition due to being partially collapsed as a result of the structure being razed. Sections of the concrete foundation have been pushed into the center of the feature.
